Appendix
WATER and RELATED LAND RESOURCES
EL RIO ARRIBA SUB-BASIN
UPPER RIO GRANDE BASIN
NEW MEXICO

PRELIMINARY
EARLY ACTION OPPORTUNITIES

A Report Based on a Cooperative Study by
THE UNITED STATES DEPARTMENT OF AGRICULTURE
and the
NEW MEXICO STATE ENGINEER

PREPARED BY
SOIL CONSERVATION SERVICE - ECONOMIC RESEARCH SERVICE - FOREST SERVICE
ALBUQUERQUE, NEW MEXICO 1969

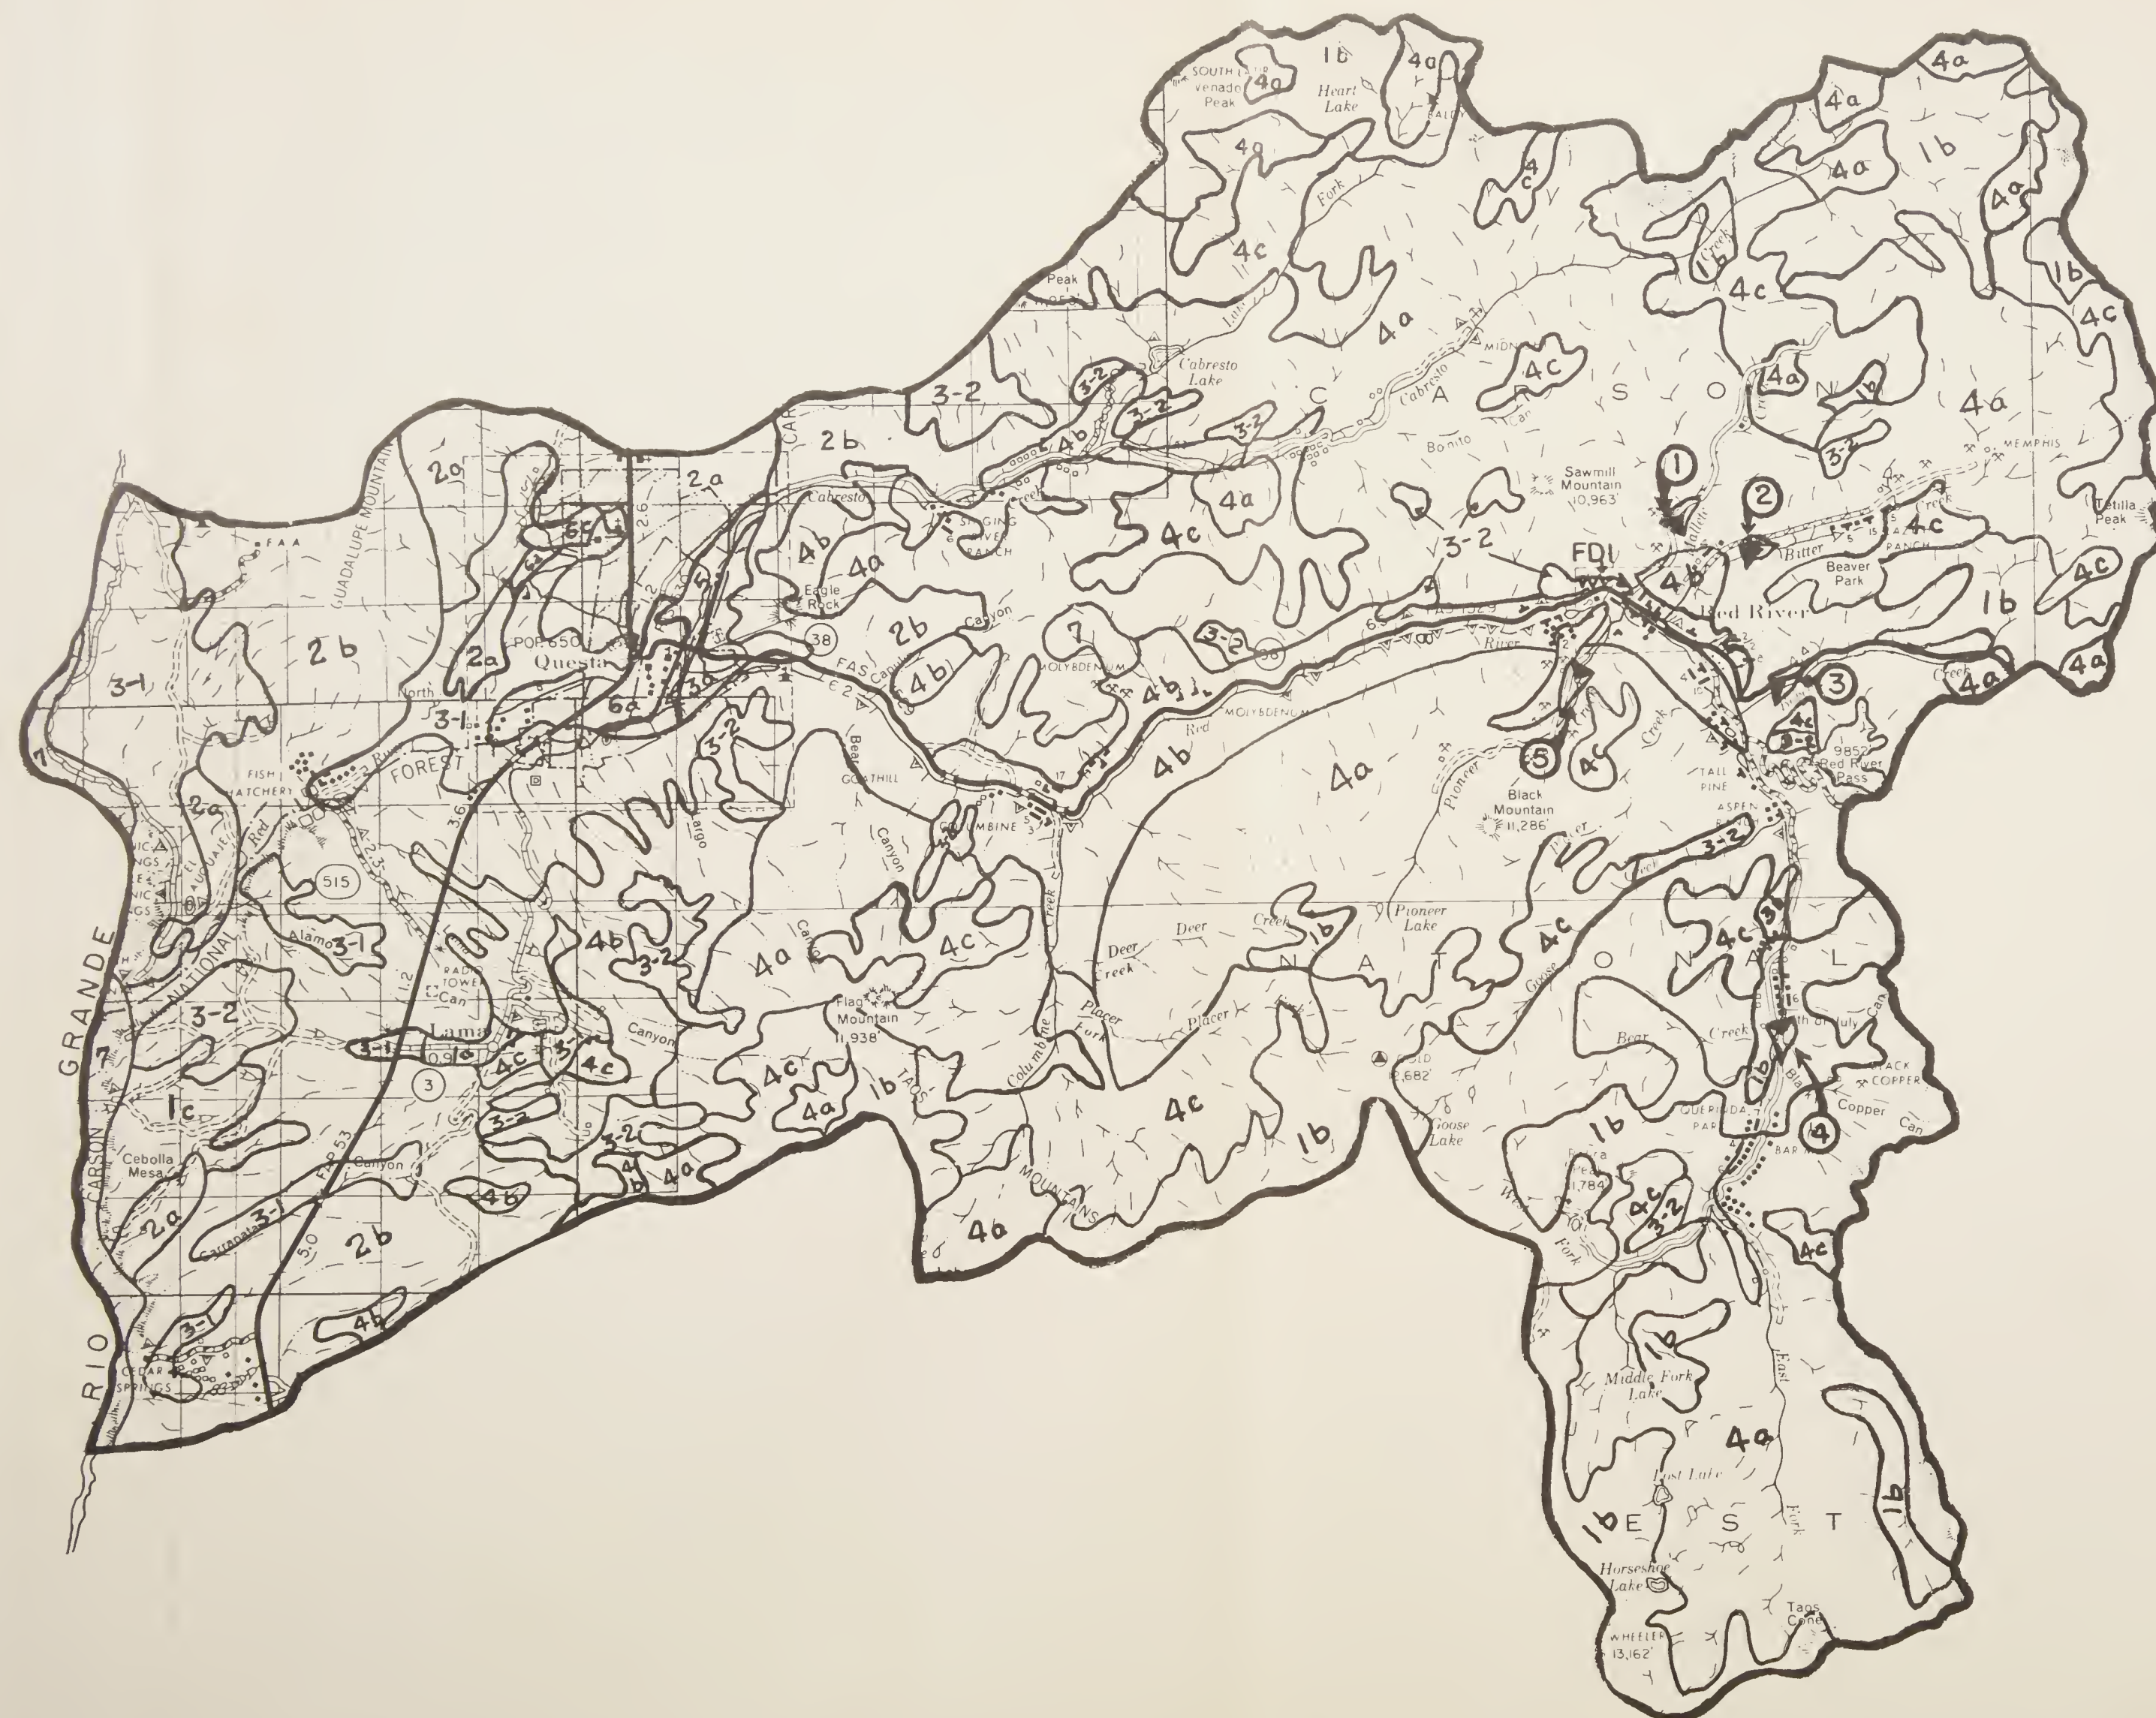
- ② SITE NUMBER
- ◁ FLOODWATER RETARD STR.
- FLOODWATER DIVERSION
- 1b SNOW PACK MANAGEMENT
- 1c GOOD RANGE MANAGEMENT
- 2a PINYON-JUNIPER CONTROL
- 2b PINYON-JUNIPER MANAGEMENT
- 3-1 SAGEBRUSH CONTROL & MGT.
- 3-2 CHAPARRAL CONTROL & MGT.
- 4a SPRUCE-FIR MANAGEMENT
- 4b PONDEROSA PINE MANAGEMENT
- 4c ASPEN MANAGEMENT
- 5 BOTTOMLAND VEGETATION MGT.
- 6 IRRIGATED LAND MANAGEMENT
- 6c ABANDONED CROPLAND MGT.
- 7 MISCELLANEOUS LAND

From the reconnaissance of the area around Red River, it was determined that flood damage and potential damage occurs in 6 locations. Proposed structural measures for flood protection include 5 floodwater retarding structures and one floodwater diversion. The approximate location of these sites is shown on the attached map. See tables 1 through 4 and figure 1. All flood control structures will be high-hazard class "c" structures.

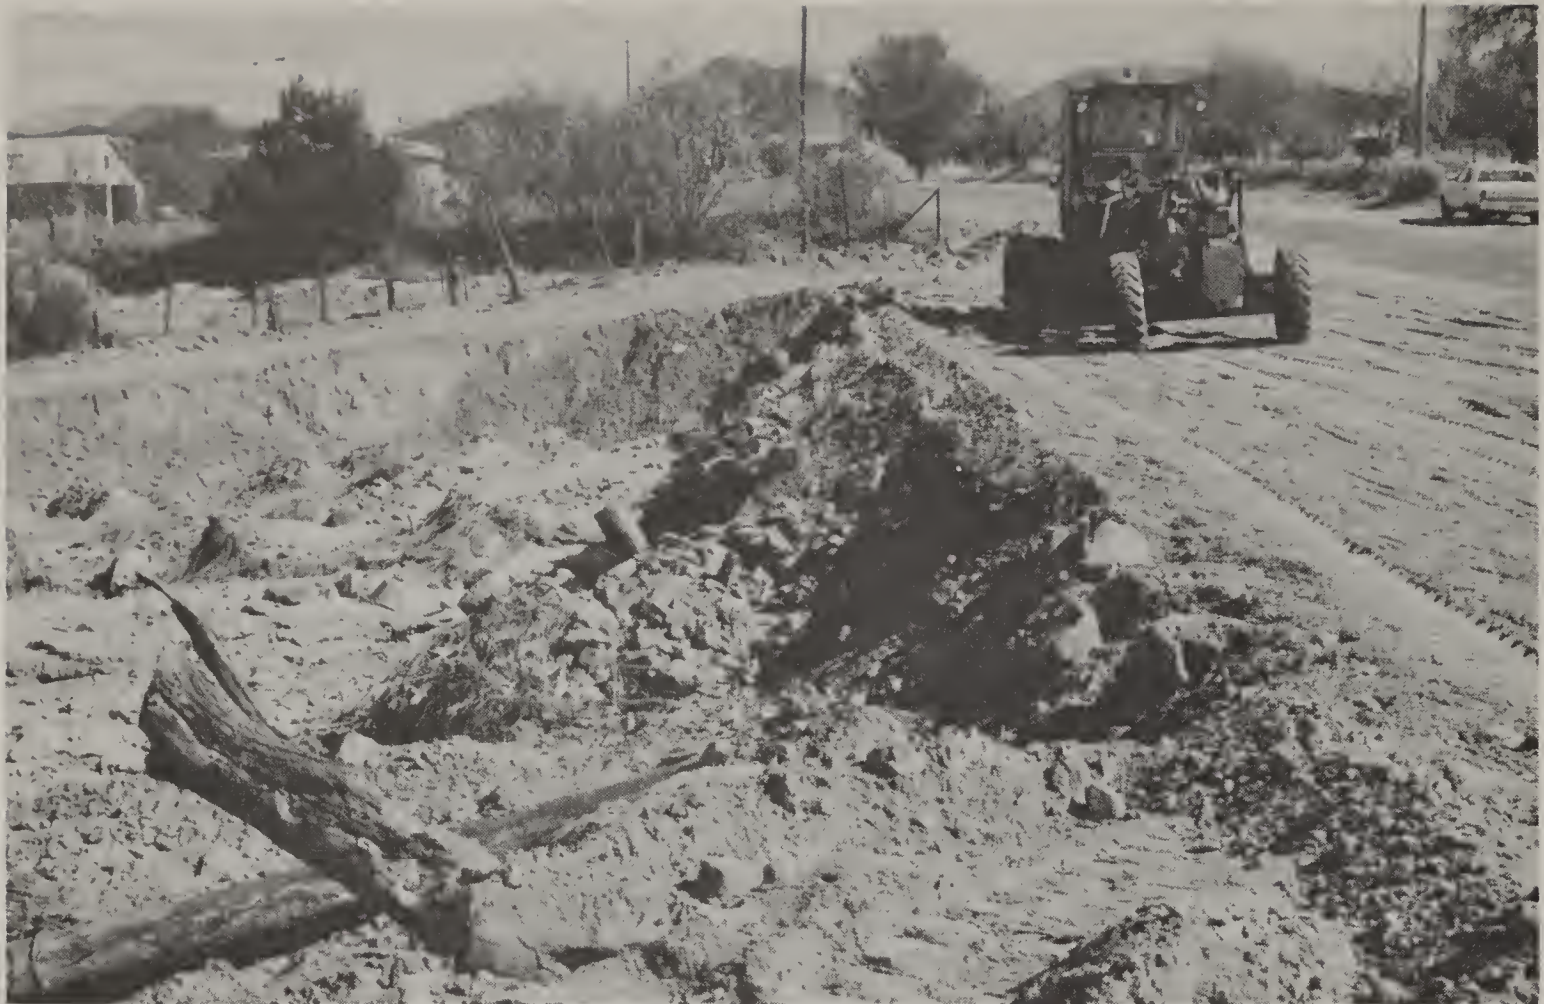
SCS PHOTO 12-P576-2

*1967 flood damage to highway at Dixon below proposed site 1.
(Soil Conservation Service photograph)*

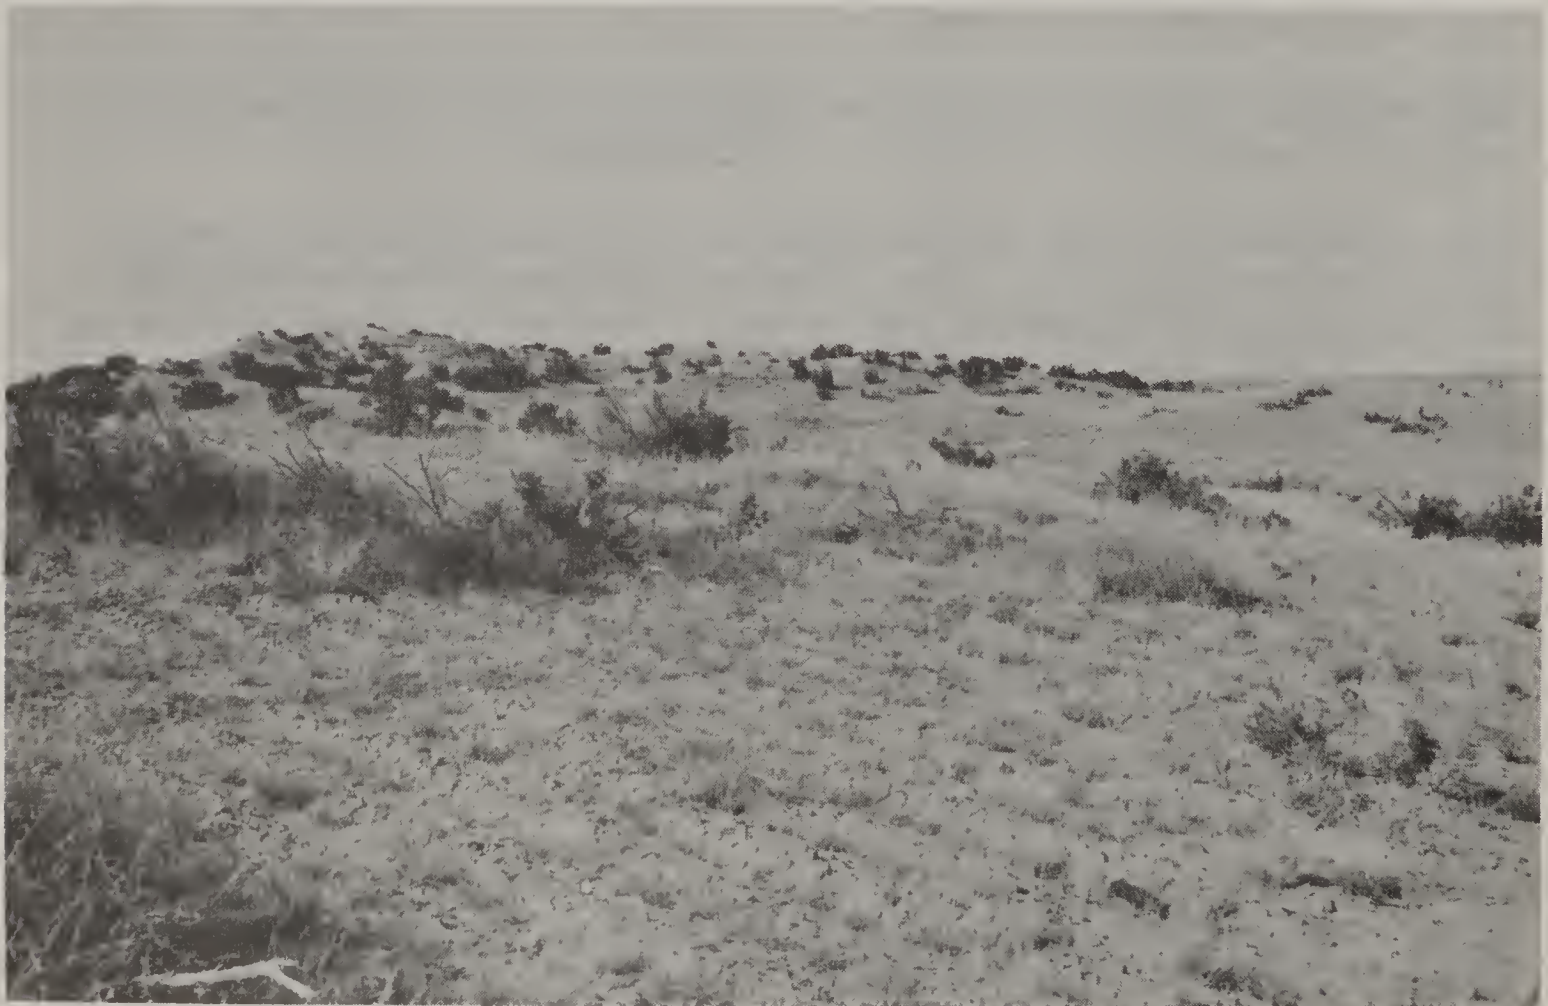
SCS PHOTO 12-P303-1

Brush control and grass seeding on Nambe Pueblo range. (Soil Conservation Service photograph)

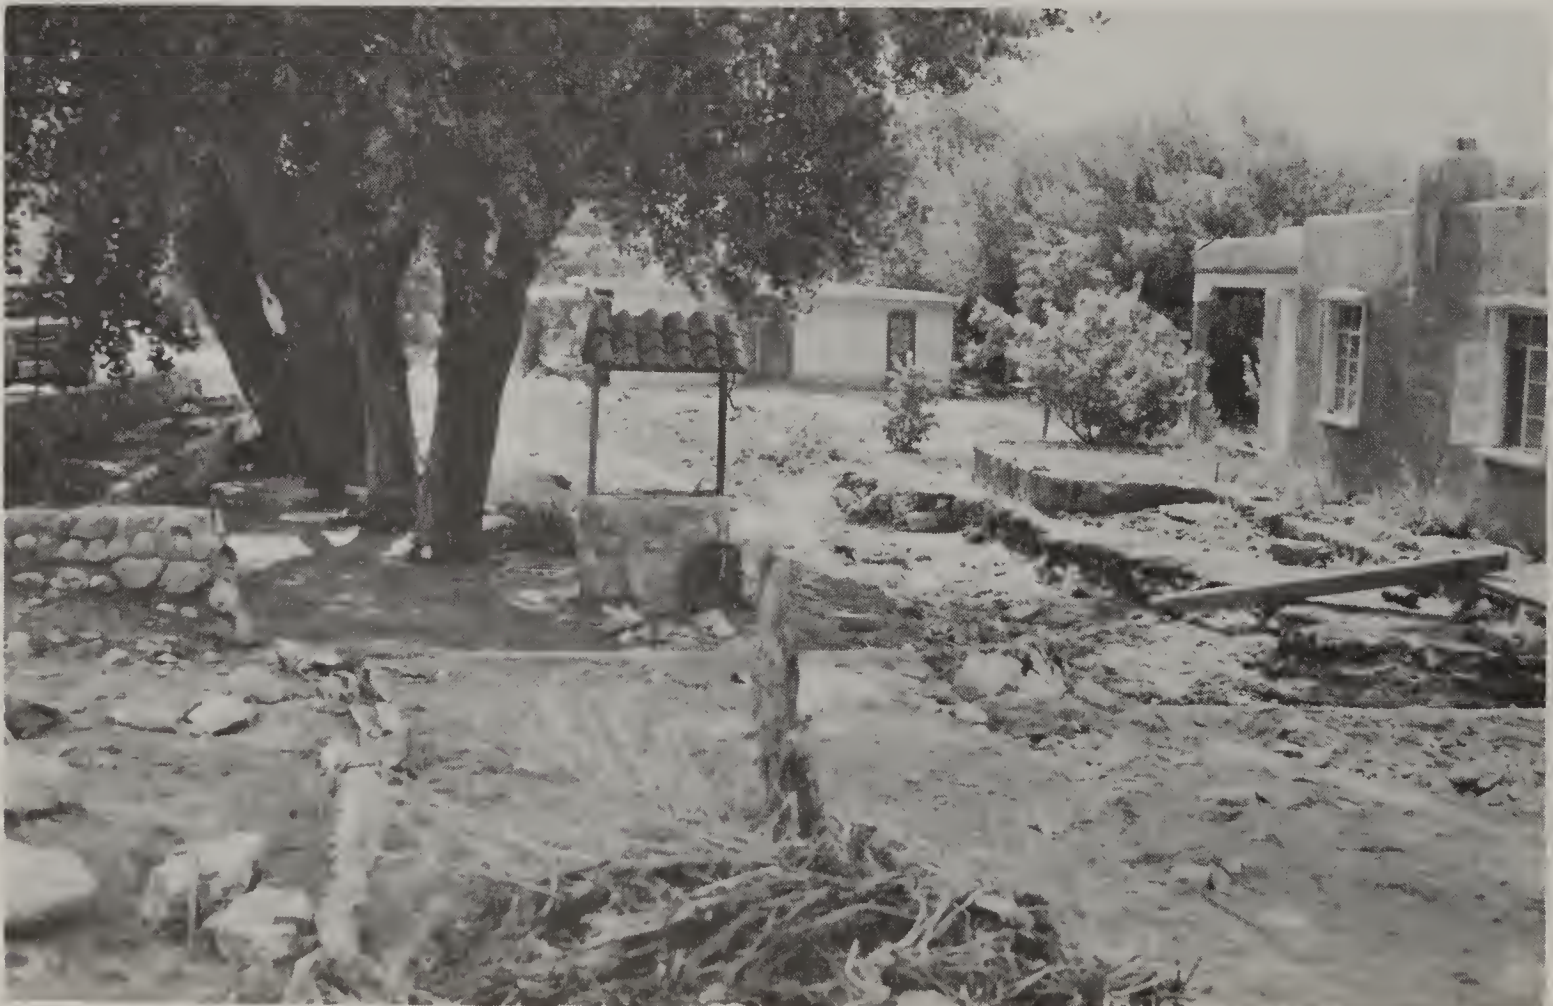
SCS PHOTO 12-P784-3

Flood damage from flood of July 25, 1968 at 1133 E. Alameda, Santa Fe (Soil Conservation Service photograph)

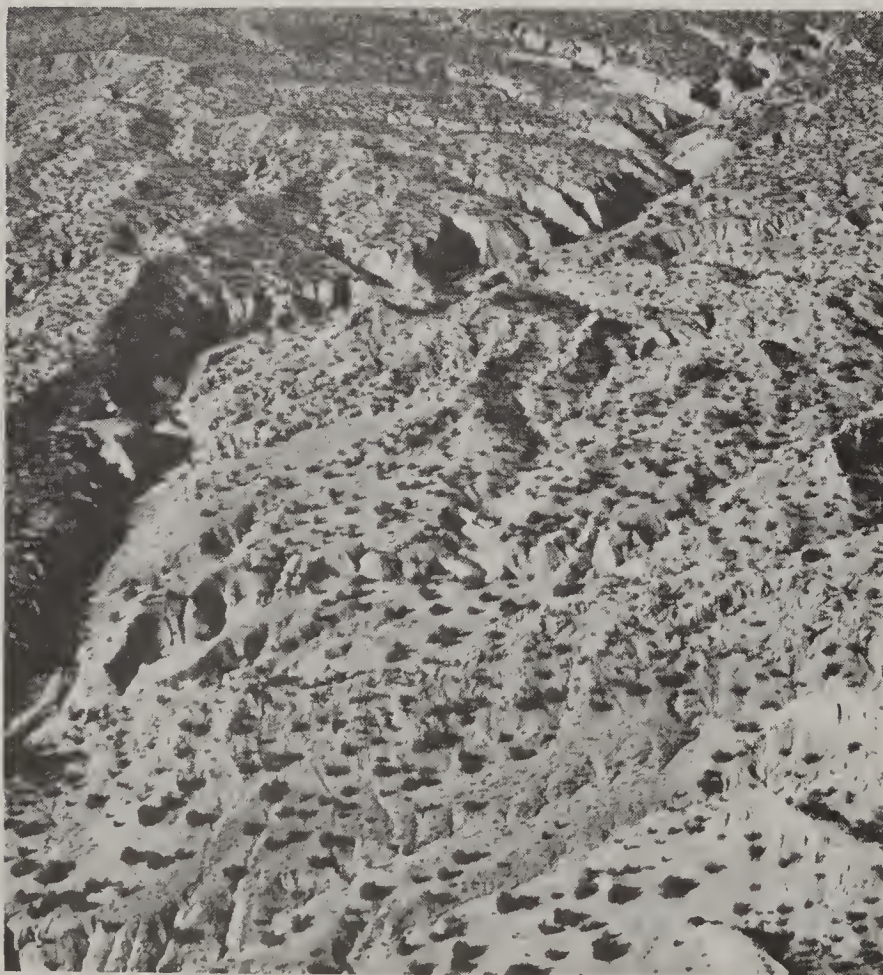
Sediment source area northwest of Espanola on Lovato Grant (Soil Conservation Service photograph)

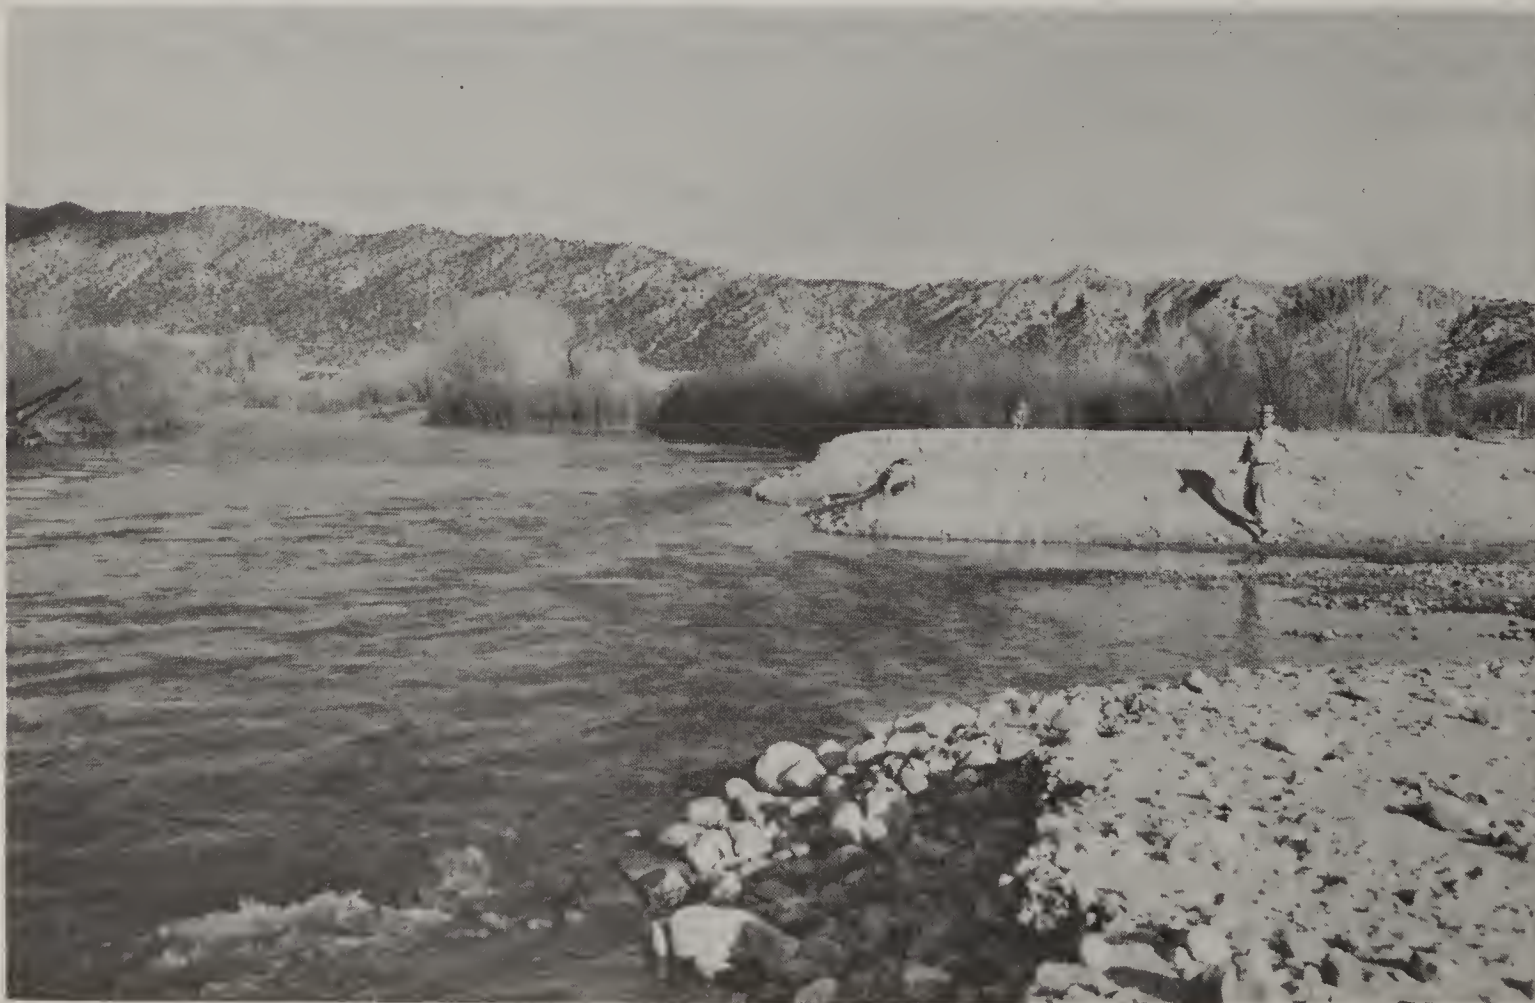
SCS PHOTO 12-P261-9

*Sediment from Rio de Truchas entering the Rio Grande
(Soil Conservation Service photograph)*

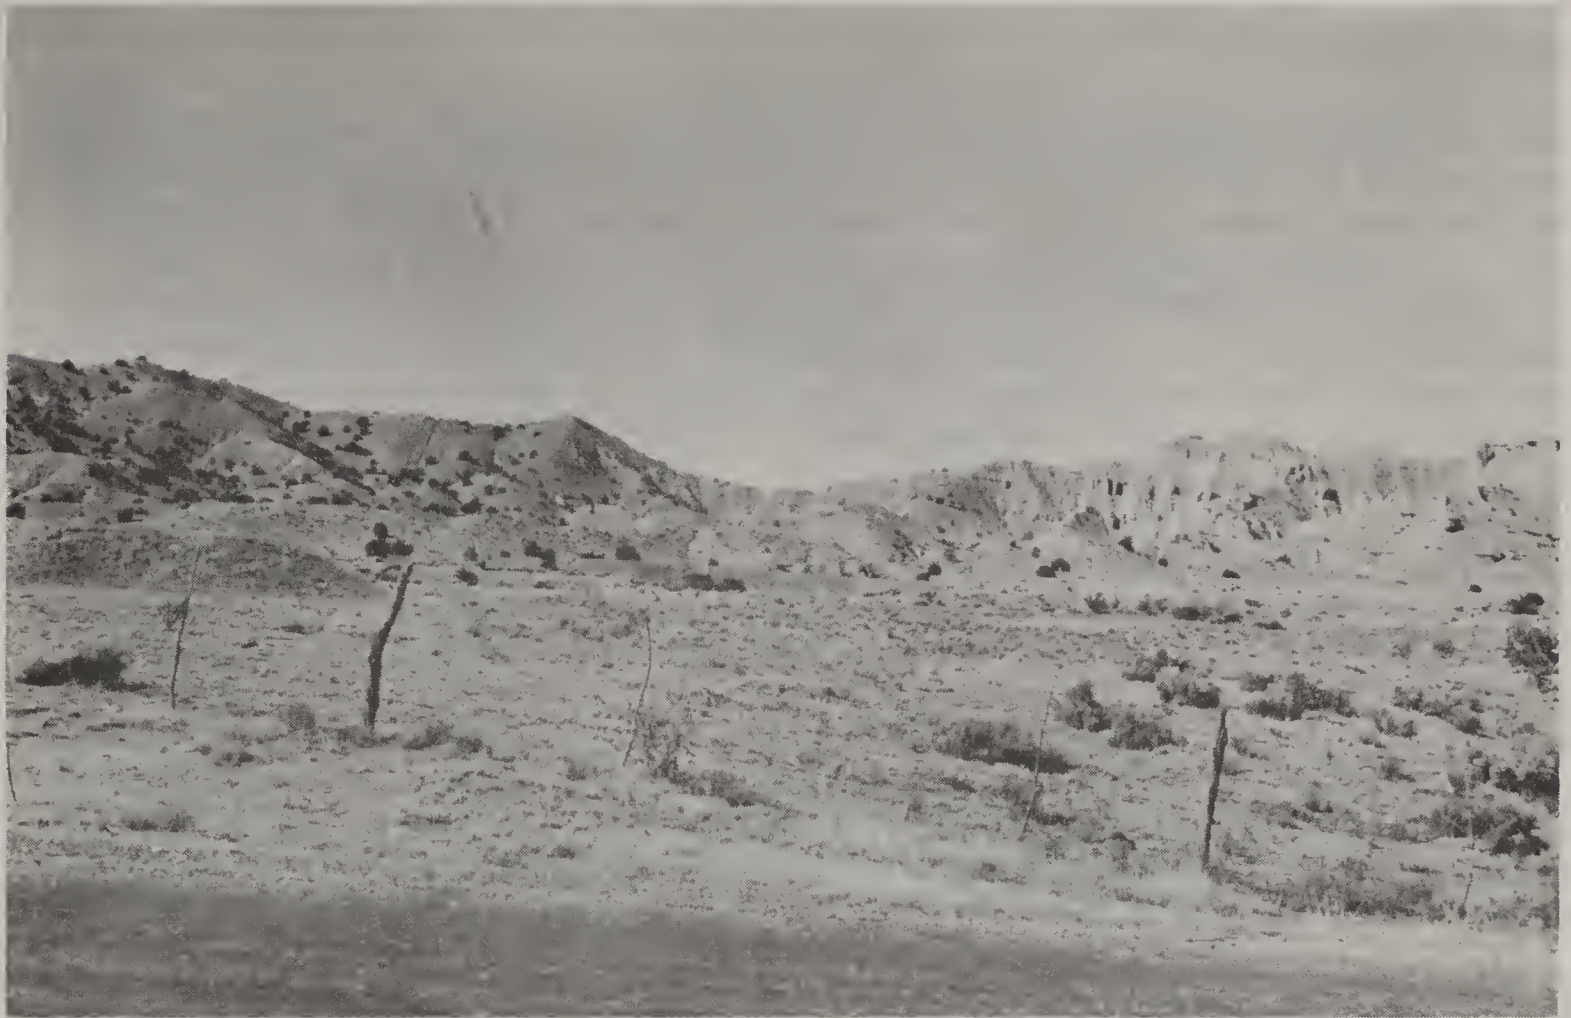
SCS PHOTO 12-P240-10

*High sediment producing area west side of Rio Grande
(Soil Conservation Service photograph)*

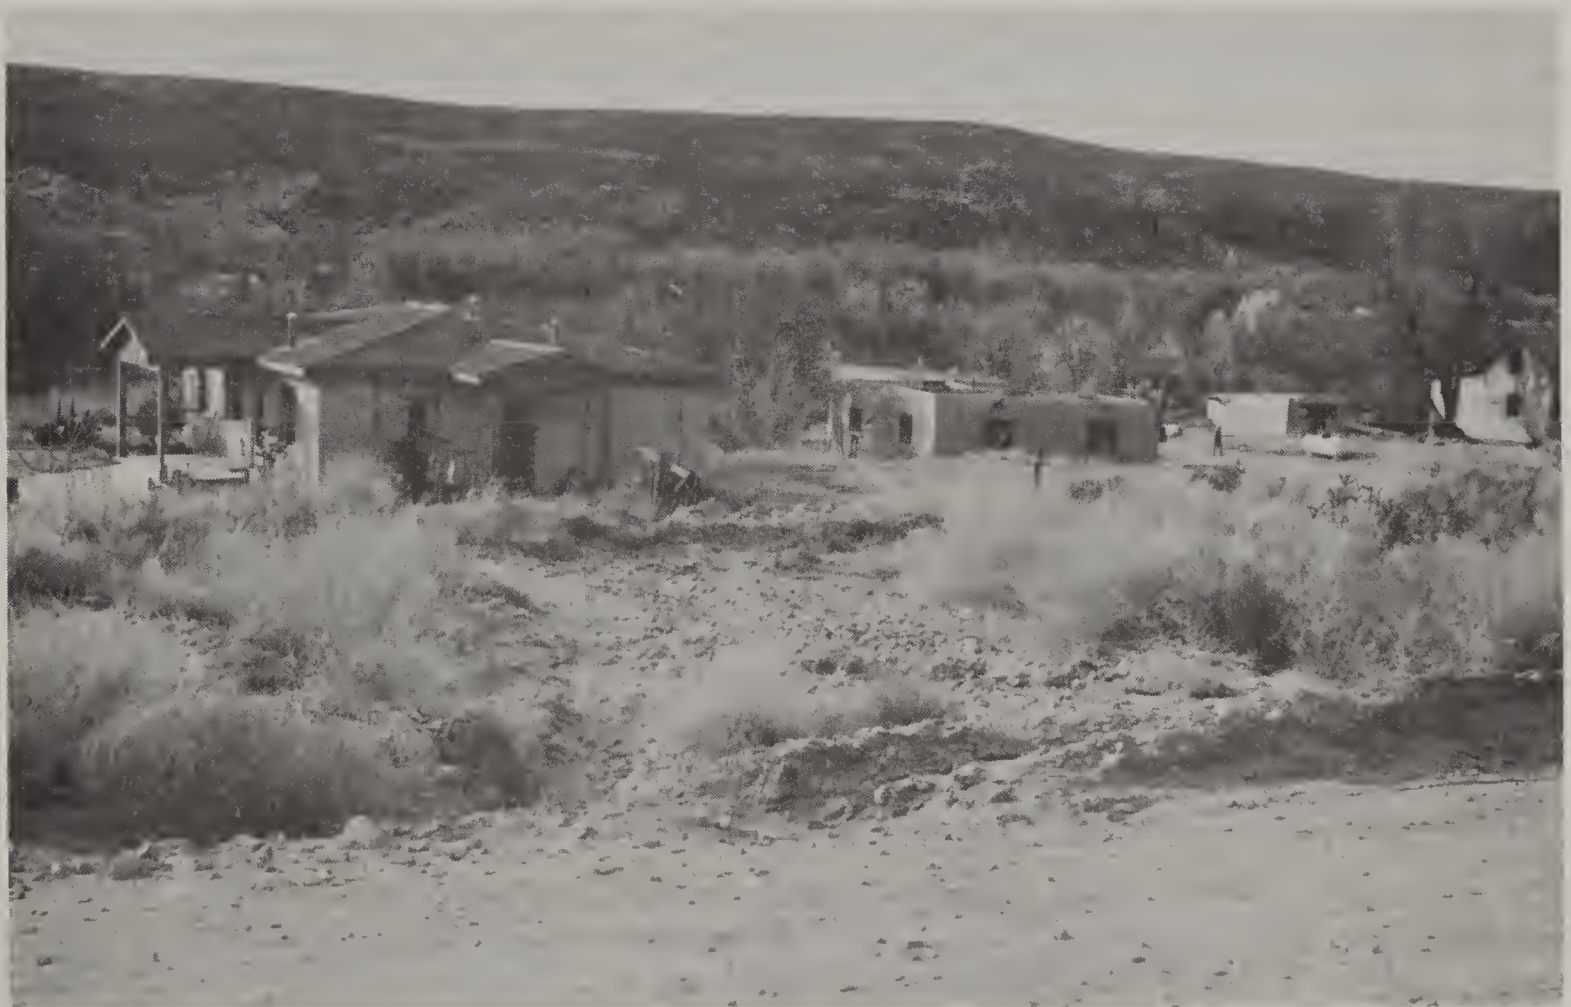
SCS PHOTO 12-P457-14

*Flood damage near Velarde School (Soil Conservation
Service photograph)*
